# **End Semester Presentation: Mechanical/ Tribological behavior of 8YSZ/MWCNTs composites under dry sliding conditions**

**PhD student**

Soukaina Lamnini

Centre for Energy Research, Hungarian Academy of Sciences

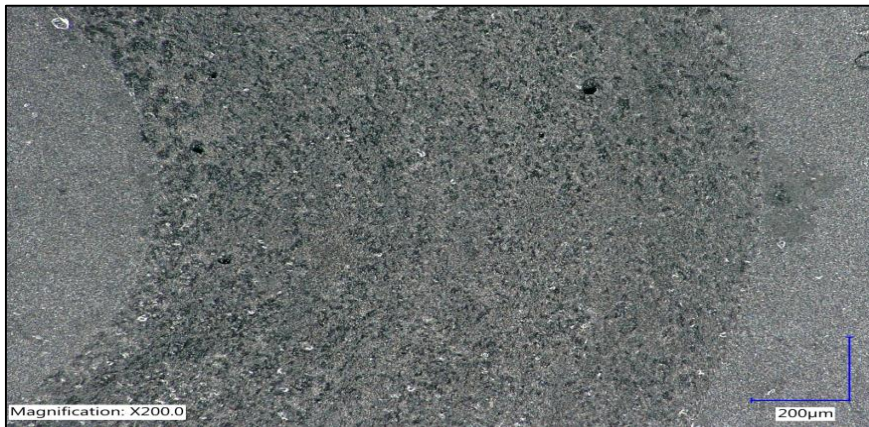
Fig.2 Wear track in the composite with 5 wt. % /MWCNTs recorded by Kenyence Microscopy

The wear rates ( $W$ ) were calculated based on the volume loss ( $V$ ) per total sliding distance ( $d$ ) :

$$W = \frac{V}{d} \left[ \frac{\text{mm}^3}{\text{m}} \right]$$

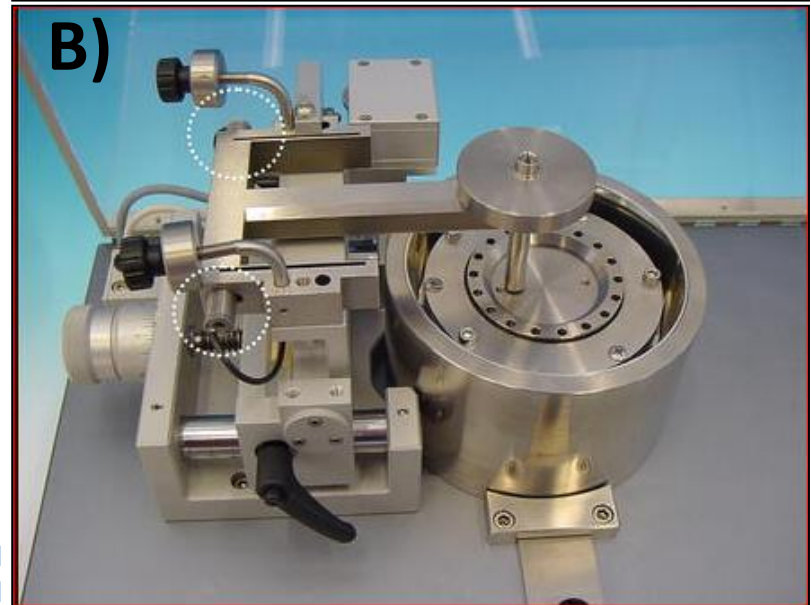
Fig.1 A) schematic design and B) real instrument of High temperature Tribometer.

- ❖ Ball-on disk technique at room temperature (25°C, air humidity 50–65%) and dry conditions.
- ❖ Counterpart: Si<sub>3</sub>N<sub>4</sub> balls with 5mm in diameter.
- ❖ Applied Load: 5 N.
- ❖ Total sliding distance: 400 m.
- ❖ Sliding speed: V1= 0.036m/s , V2= 0.11m/s .

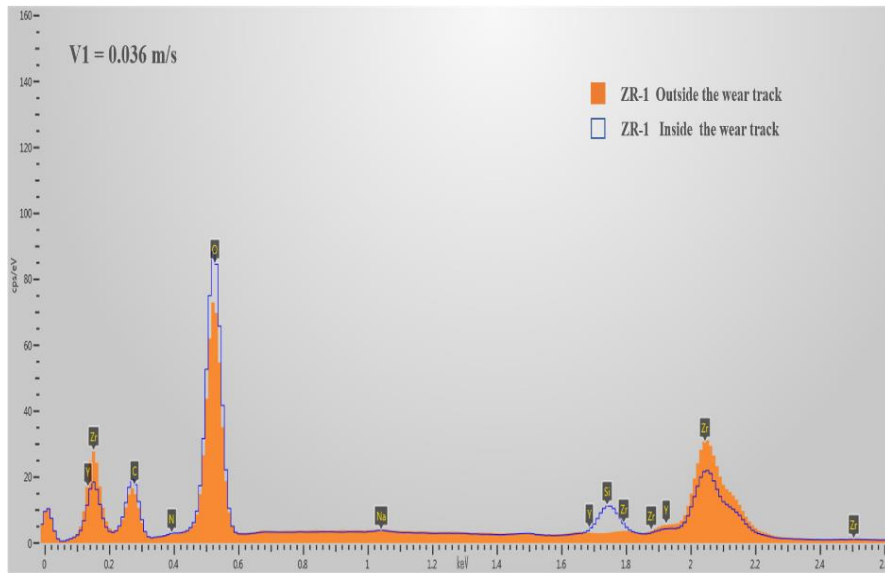
Fig.10 (EDS) inside and outside the wear track profile of (composite with 1 wt. % MWCNTs) via V1

- Observation of minor decrease of **(Zr)** which systematically induced a slight increase of **(O)** peak due to debonding mechanism with presence of **(Si)** peak.
- **(C)** peak kept similar intensity as the unworn surface.

- Similar peak tendency is approved when increasing the speed, with intensive **(Si)** and **(O)** peaks, therefore **(Zr)** peak lowered.

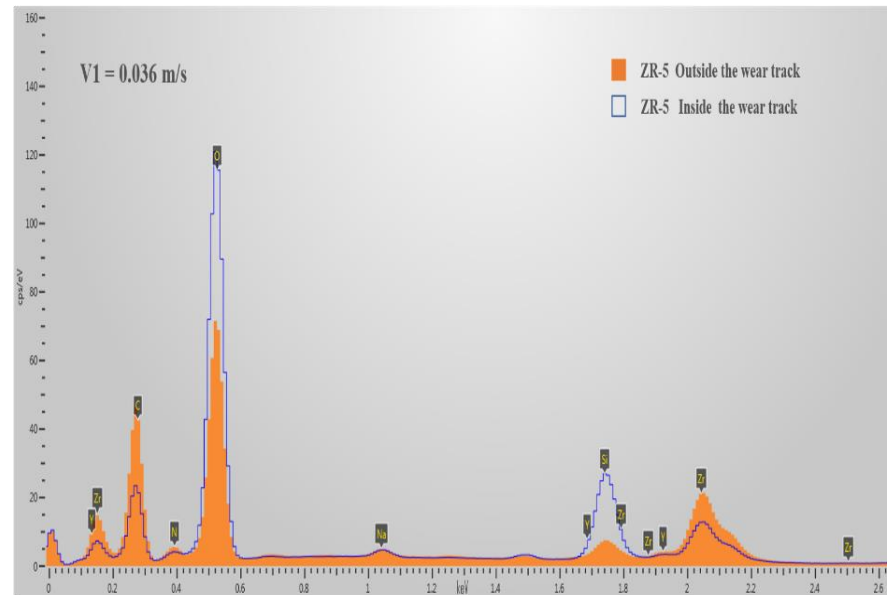
Fig.11 (EDS) inside and outside the wear track profile of (composite with 5 wt. % MWCNTs) via V1

- The intensities of (Si) peak and (O) peak are recorded to increase simultaneously with MWCNTs content till attending its highest values with 10 wt. % /MWCNTs addition at V1.
- (Si) peaks were intensified essentially by the increase of sliding speed.
- A sharp decrease of (C) peak intensity with both 5 wt. % and 10 wt. % /MWCNTs.
- Composite with 5 wt. %/MWCNTs manifested the lowest decrease of (C) peak at V2 justifying the improved friction (Lubrication effect).
- (Zr) peak increased slightly despite the high increase intensity of (O) peak with 10/MWCNTs addition:
  - (Zr) particles were not scattered to form wear debris but were induced into the so-formed SiO<sub>2</sub> layer giving rise to compacted and dense tribo-film as confirmed by SEM.
